Manhole Inspection Summary

Manhole # S23KK1001MH

Location Address: **4501 FALLS RD** Cross Street: **COLD SPRING LN**

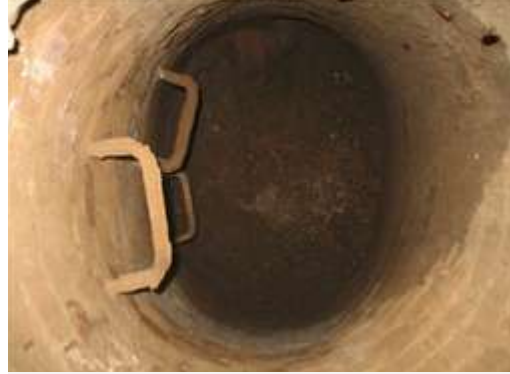
Top View

Corroded steps. Corbel and Barrel infiltration. Channel debris.

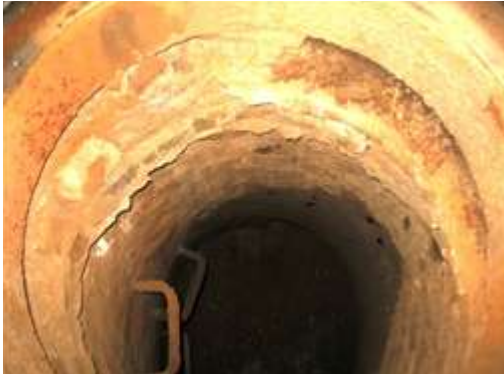
Defect

Frame leaks. Frame offset. Adjustment deterioration and infiltration. Barrel infiltration.

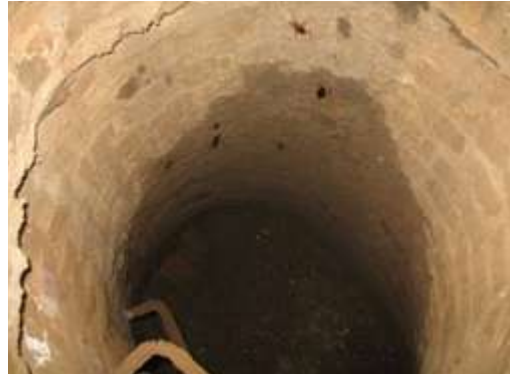
Defect

Frame leaks. Frame offset. Adjustment deterioration and infiltration. Barrel infiltration - other side.
